Article No.:TASC Tip-02-08Author:Bob WarnkeTotal Pages:3

## TECHNICALLY Speaking

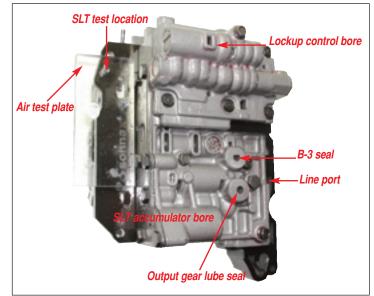
Figure 4

Before removing the valve body from the transmission, you can perform a visual Wet Air Test of the SLT circuit. If you pressurize the SLT port with shop air (80-100 psi), air pressure will push fluid, which you see as a leak. Problematic leaks occur at the steel side cover, SLT accumulator,

B-1 and C-1 control valves. A major leak – or combination of leaks – can cause delayed engagements or flare upshift and should be inspected after disassembled.

You can perform a similar air test with the valve body itself (see Figure 4). When doing so, the pump line port and thermal element hole must be closed and the separator plate held as shown to eliminate cross leaks. This might sound confusing in print, but when you do it, the ports will be evident and easy to close with your other hand.

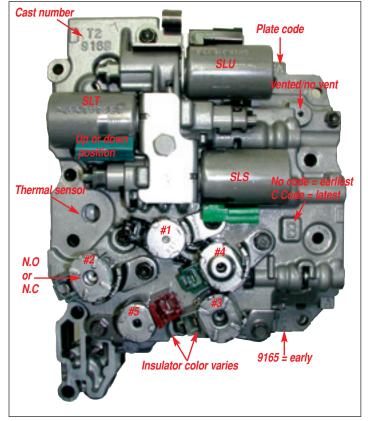
There are many variations, which complicates coring and matching parts. Figure 5 identifies visual changes. Currently there are six different shift solenoids, four of which can be installed in the wrong locations or replaced by a normally open vs. normally closed solenoid. The shift solenoids should be checked for proper flow when open and for sealing when closed. These are fed line pressure from an orifice in the plate, and can be over-pressurized.

Three linear solenoids are calibrated to the valve body. Exchanging SLT and SLS solenoids between cores without adjusting to the valves is generally not acceptable. Don't hesitate to open and inspect the valve body

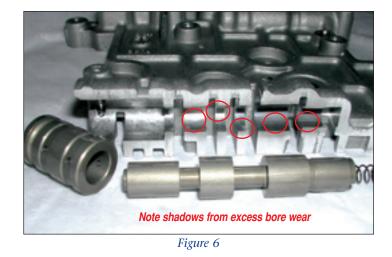
since it's comparable to other Aisin Warner designs and is not difficult to reassemble. That inspection should include all the removable sleeves, both regulator valves and the solenoid modulator bore. The linear solenoids are fed by this modulator valve, which limits the maximum pressure. When that bore is worn, the concern is similar to a bad GM actuator feed circuit.

Excess wear appears as a discoloration, or polished area, in the shape of a moon phase, generally at the ends of the bore or opposite side of fluid entry (see Figure 6).
